MILLRIDGE HOMEOWNERS ASSOCIATION
MAINTENANCE PLAN UPDATE
RESERVE STUDY
LEVEL II: UPDATE WITH VISUAL SITE INSPECTION
2018

MILLRIDGE HOMEOWNERS ASSOCIATION

**Millridge Homeowners Association
Maintenance Plan Update
Reserve Study Update – Onsite
Disclosure Information
2018**

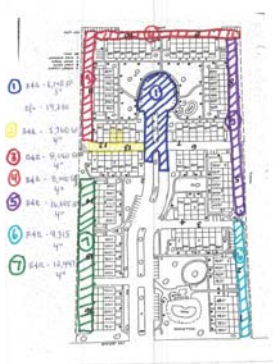
Asphalt Overlay - Area #1 continued...

This provision funds for an overlay of the asphalt area at the cul de sac on the main road.

Coast Pavement Services identified this section as area #1. In 2018, they provided a cost of \$43,484 to remove three inches and replace with a two-inch overlay. There are 25,420 square feet of asphalt in this area.

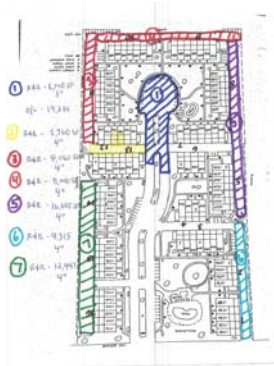
Asphalt Overlay - Area #3 & #4 continued...

This provision funds for an overlay of asphalt areas #3 and #4.

The areas were identified by Coast Pavement Services. They provided a cost of \$29,016 for area #3 and \$28,800 for area #4. This is to remove and replace four inches of the asphalt. There are 16,060 square feet of asphalt in these areas.

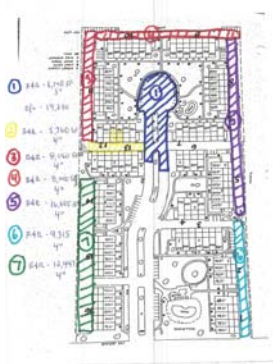
Asphalt Overlay - Area #6 & #7 continued...

This provision funds for an overlay of asphalt areas #6 and #7.

The areas were identified by Coast Pavement Services. They provided a cost of \$36,602 for area #6 and \$43,564 for area #7. This is to remove and replace four inches of the asphalt. There are 21,762 square feet of asphalt in these areas.

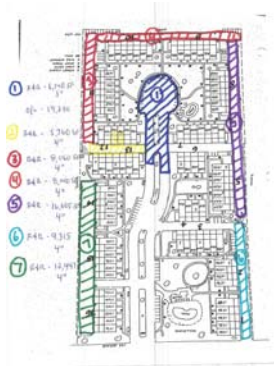
Asphalt Overlay - Area #6 & #7 continued...

This provision funds for overlay of the asphalt area #6 and #7.

The areas were identified by Coast Pavement Services. There are 21,762 square feet in these areas.

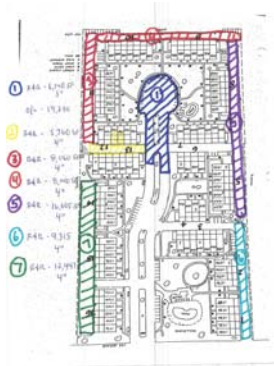
Asphalt Replacement - Area #2 & #3 continued...

This provision funds for a replacement of asphalt areas #2 through #3.

The areas were identified by Coast Pavement Services. They provided a cost of \$23,040 for area #2 and \$29,016 for area #3. This is to remove and replace four inches of the asphalt. There are 13,820 square feet of asphalt in these areas.

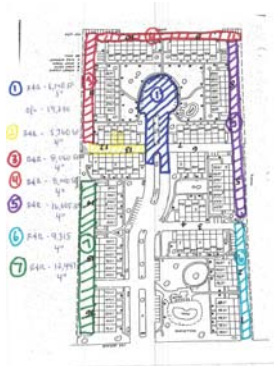
Asphalt Replacement - Area #4 & #5 continued...

This provision funds for a replacement of asphalt areas #4 and #5.

The areas were identified by Coast Pavement Services. They provided a cost of \$28,800 for area #4 and \$58,117 for area #5. This is to remove and replace four inches of the asphalt. There are 24,605 square feet of asphalt in these areas.

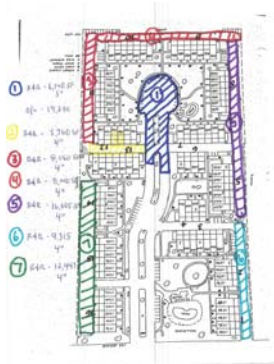
Asphalt Replacement - Area #6 & #7 continued...

This provision funds for a replacement of asphalt areas #6 and #7.

The areas were identified by Coast Pavement Services. They provided a cost of \$36,602 for area #6 and \$43,564 for area #7. This is to remove and replace four inches of the asphalt. There are 21,762 square feet of asphalt in these areas.

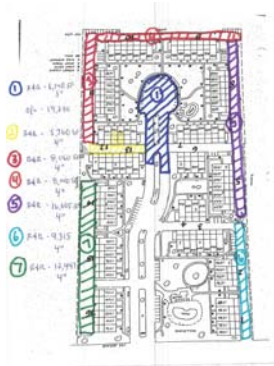
Asphalt Seal Coat - Area #1 continued...

This provision funds for an overlay of the asphalt area at the cul de sac on the main road.

Coast Pavement Services identified this section as area #1. In 2018, they provided a cost of \$43,484 to remove three inches and replace with a two-inch overlay. There are 25,420 square feet of asphalt in this area.

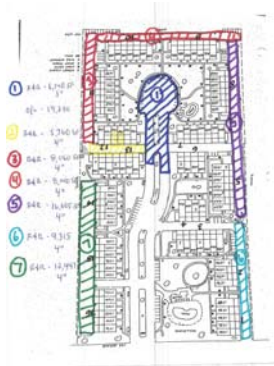
Asphalt Seal Coat - Area #3 & #4 continued...

This provision funds for a replacement of asphalt areas #3 and #4.

The areas were identified by Coast Pavement Services. There are 16,060 square feet of asphalt in these areas.

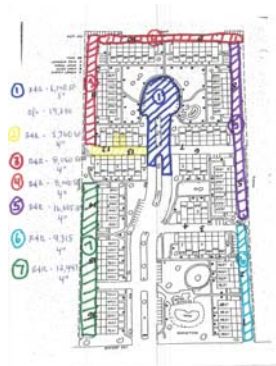
Asphalt Seal Coat - Area #5 continued...

This provision funds for a replacement of asphalt area #5.

The areas were identified by Coast Pavement Services. There are 16,605 square feet of asphalt in these areas.

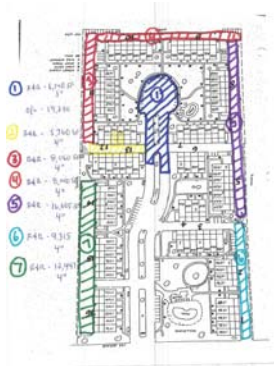
Asphalt Seal Coat - Area #6 & #7 continued...

This provision funds for seal coating of the asphalt area #6 and #7.

The areas were identified by Coast Pavement Services. There are 21,762 square feet in these areas.

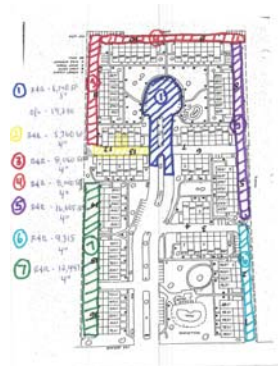
Asphalt Seal Coat: Area #2 & #3 continued...

This provision funds for seal coating of the asphalt areas #2 and #3.

The areas were identified by Coast Pavement Services. There are 13,820 square feet of asphalt in these areas.
